Flint Faience Fireplace (continued)

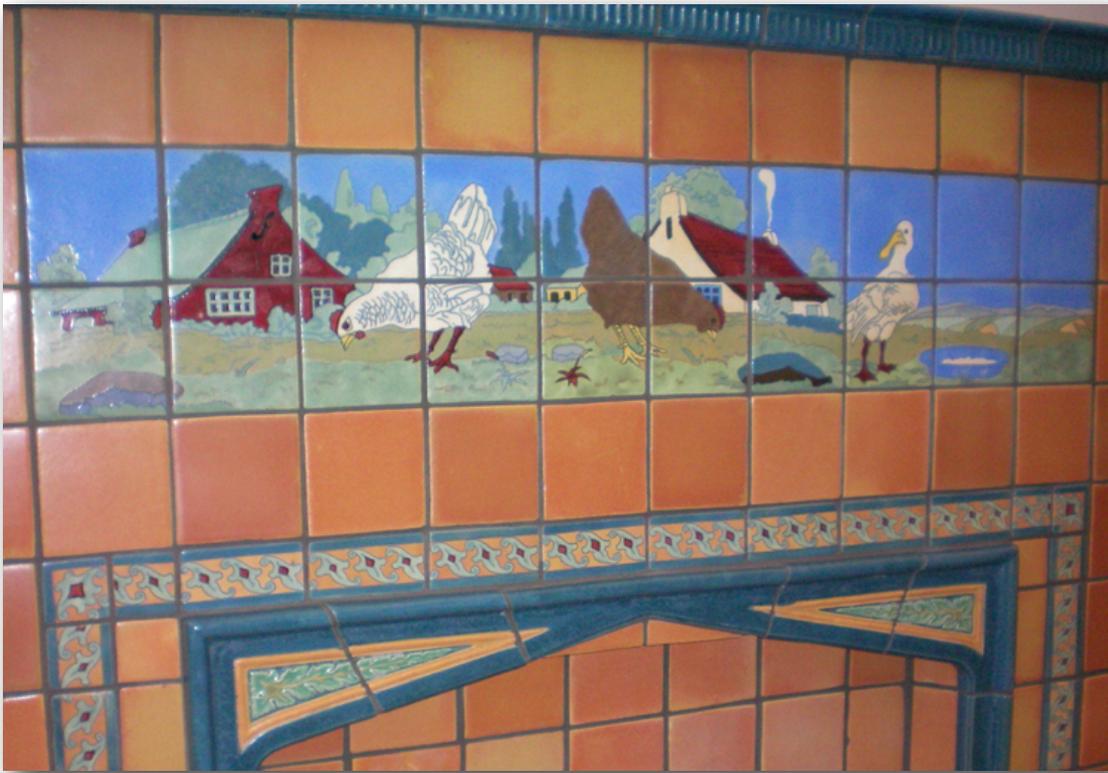
After cleaning the barnyard mural I discovered that the way it had been originally installed was wrong. There was part of the duck's tail in the middle of the mural where it didn't belong! For the reinstallation the Cranford Preservation Board decided to change the position of the tiles in the mural when I went back to install the fireplace in October 2013. The fireplace was installed in the lobby of the Cranford Community Center, 220 Walnut Avenue. The board also decided to raise the hearth six inches up from the floor. The base was built by Chris Siano, a local contractor. We used the extra tiles I had removed to raise the hearth so that no one could trip on the tiles.

Rearranged Flint Faience mural at the Cranford Community Center. The duck has now retrieved its tail!

All tiles were boxed and then stored at my home because the school district had no money or place to store the tiles. Over time I worked on repairing the tiles that were broken or where the glaze was peeling. I glued the broken tiles together with super glue, filled the gaps with plaster and painted.

We made some changes on the fireplace to make it suitable for the space. Blue tiles were taken from the mantle to use on the raised hearth and 3x3 blue tiles on the side of the hearth. Gold tiles from the hearth were used in the firebox and the extra gold tiles were used on the side and top of the fireplace. The space between the tile and wall will be covered with oak plywood paneling. The tiles were glued to the drywall form with thin set at ¼-inch grout joints and grouted with natural grey grout. It took three days to recreate the fireplace. Karen Mobley helped unpack tiles and set out the numbered tiles in the proper order. The biggest help was her talking to the people that were asking questions so I could work with little interference!
